Electrical Safety in the farm: Case Study Research at Michigan USA 2010

Fathurrahman

Abstract

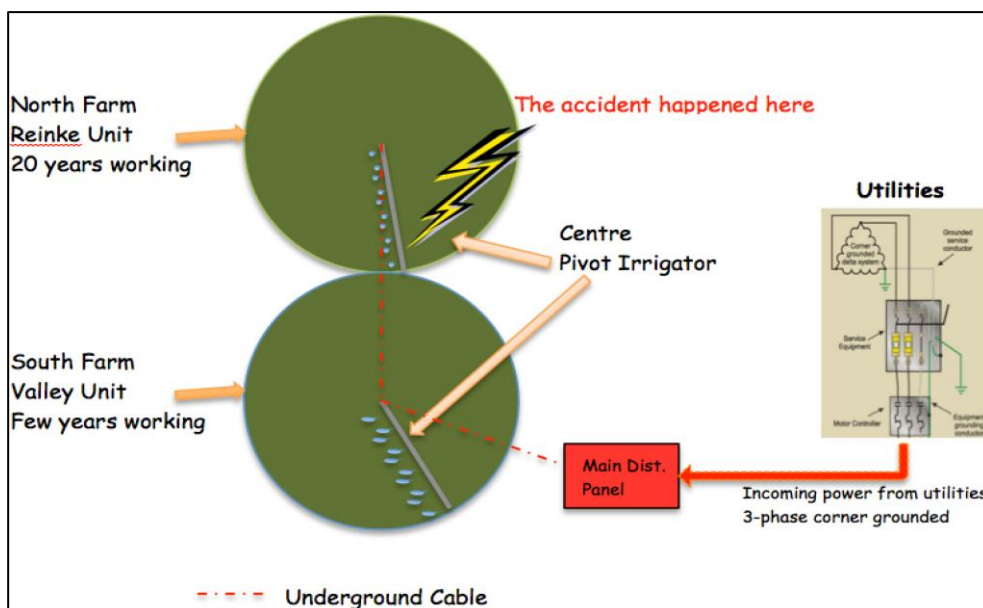
Figure 2. Overview of potato farms where the accident is happened. (Recreated based on investigation report narrative.)

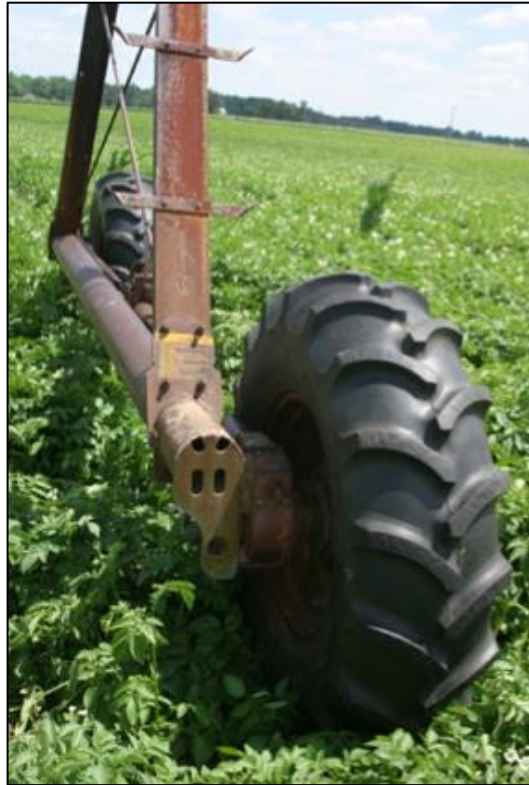
At around 02.43 a.m. the three farm workers were approaching active overhead irrigator. The victims tell the other two workers to get hurry and pass by the irrigator system (Reinke unit, north farm). However, the victim was behind the other two workers. The other two worker had already pass by the overhear irrigator system and ahead of the victims by several meters, and they were all soaked by the irrigator system. At approximately 02.45 a.m. the victims were standing in the puddle of water right below the irrigator system and beside one of its self-propelled tower. According of his two friends, he was unintentionally touched the brace-arm of the tower while pulling the corn plantation. The minute he touched the tower, he yelled at loud and then suddenly leaning against the tower bar.

Figure 3. The tower where the accident happened (MIFAHE and MSU, 2012).

After examined the underground cable system, it was concluded that at the time of accident the victim was providing a conduction path from the ground (faulty cable either phase A or C) to the tower (ground) which has 480 V potential different. It is usual for the underground cable that struck by lightning to work for a while even though in the fault condition, therefore the protection system did not react. The worker was exposed to the amount of the current, which caused ventricular fibrillation for long period (more than three minute). That condition is enough to kill one the victims on the spot. The other contributing cause of the accident is presented below.

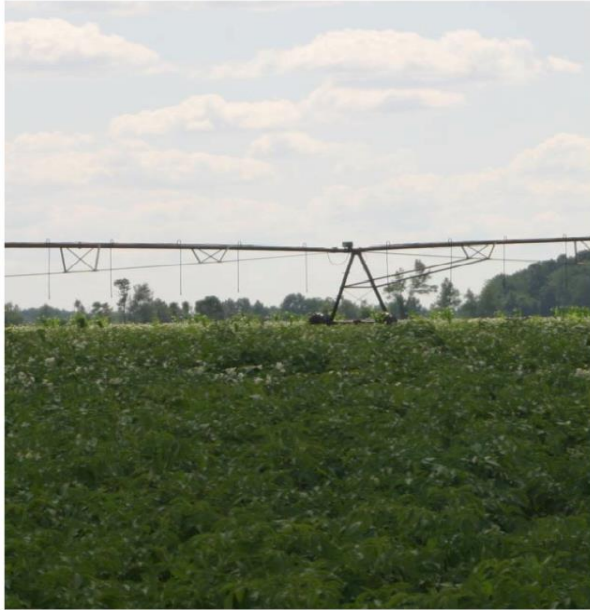
Figure 1. Irrigation unit involved in incident.

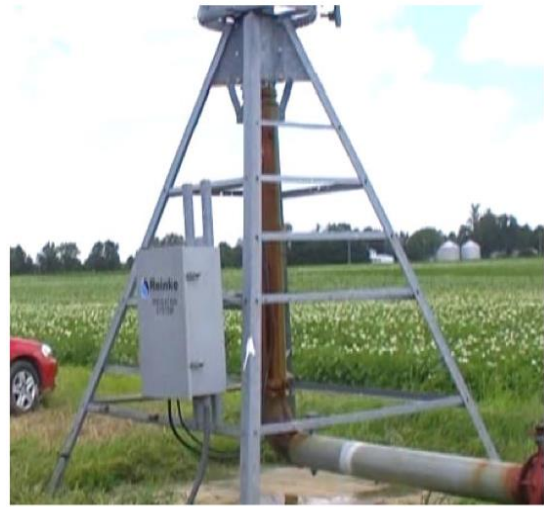
Figure 2. Center pivot involved in incident.

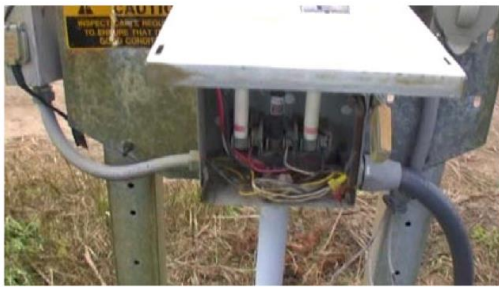
Figure 3. Power supply to Valley Pivot. Valley Pivot plugged into receptacle.

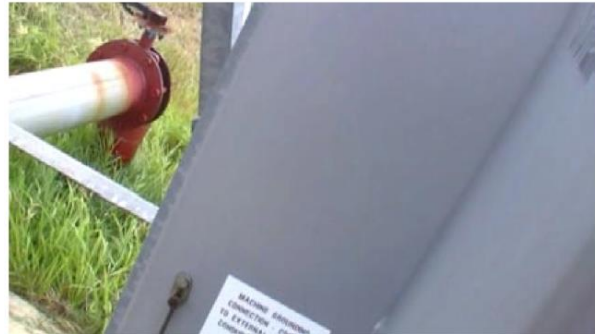
Figure 4. Machine ground of Reinke central pivot.

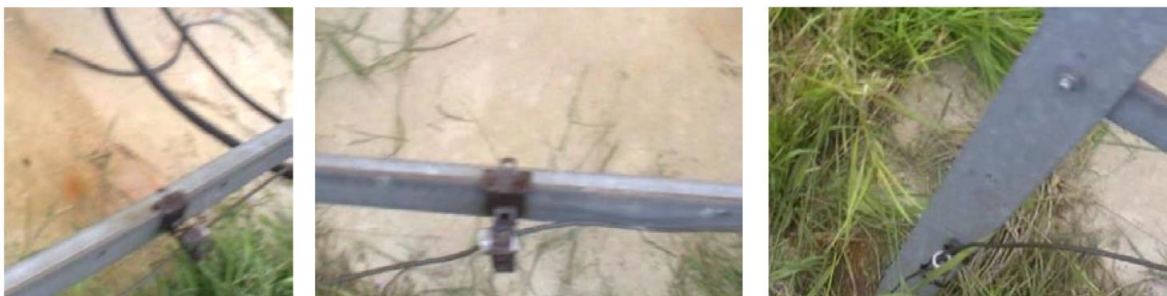
Figures 5-7. Path of Reinke ground wire.
