THE EVALUATION OF BUILDING'S STRUCTURAL RELIABILITY OF MASJID TUHA INDRAPURI, ACEH BESAR

Riza Aulia Putra*, Saiful Hadi**

Keywords: Masjid Tuha Indrapuri, building performance, forensic engineering method.

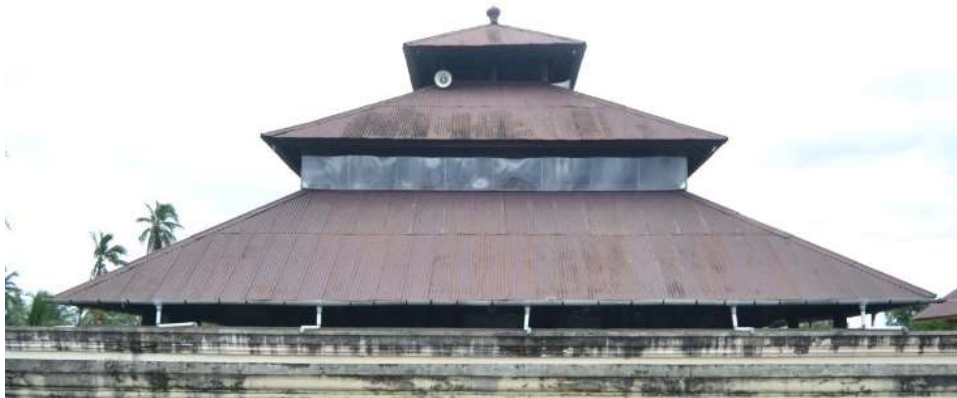
Based on Table 1, it shows that the robustness value of the entire building is 82.7%, this means that the condition of Masjid Tuha Indrapuri construction is in a good condition. The roof has a decrease in robustness of 11.5%, this is because the roof cover looks mossy and poorly maintained. While the roof frame appears in good condition and can not be repaired.

Figure 2. The Roof Condition of The Mosque (source: Putra, 2018)

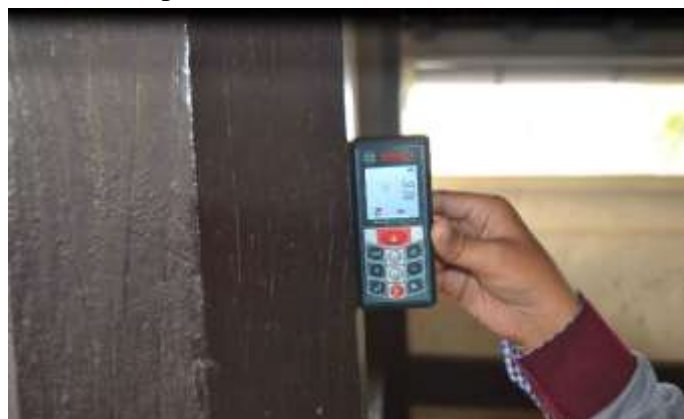
Furthermore, the state of the frames of Masjid Tuha Indrapuri construction from the field observation has decreased in robustness by 9.5%. This is due to the building pillars that have slopes although it is in a very small measure, as seen in figure 5.1, the protractor reading meter shows the number 87.8° , this means that one of the pillars has a slope of 2.2° .

Figure 3. The Slope Measurement of The Mosque's Pillar (source: Putra, 2018)

However, the overall robustness of the building frames is 17.2%, while the maximum value for the frame is 19%. Thus, the condition of the frames of the mosque in general is still in a good condition.

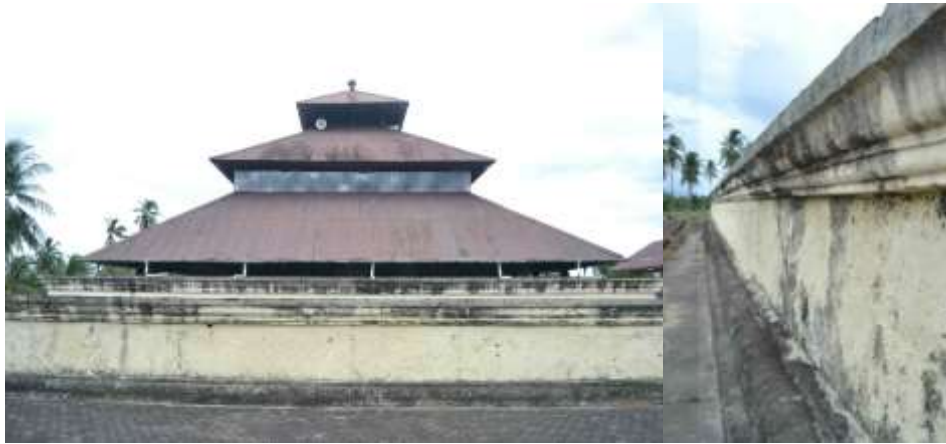
The other construction components which also experience a decrease in robustness are walls, namely 20%. The walls of the mosque are made of concrete, from the observations in the field, the condition of the walls is not too well maintained, many parts of the wall shows that the paint has peeled off and covered by moss. The wall plastering also seems rough, although there are no cracks that can affect the strength of the structure.

Figure 4. The View of The Mosque (left) and The Condition of The Mosque Walls (Right)
(source: Putra, 2018)
