THE EVALUATION OF BUILDING'S STRUCTURAL RELIABILITY OF MASJID TUHA INDRAPURI, ACEH BESAR

Riza Aulia Putra*, Saiful Hadi**

Keywords: Masjid Tuha Indrapuri, building performance, forensic engineering method.

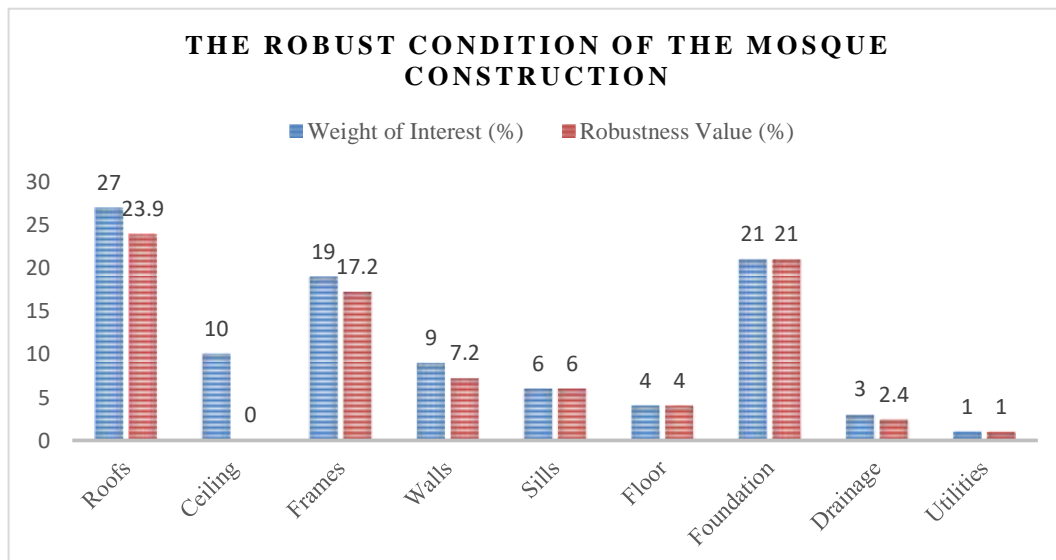
Figure 5. The comparison between weight of interest and the existing condition (source: Analysis)

The comparison between the weight of interest and the existing condition of the mosque is shown in the following figure 5:
